**Flood Control Project Maintenance  
Levee Inspections****LMA District Cover Sheet****Spring 2015 Levee Inspection Results****Levee District No. 0001 (Sutter County)**

**Levee Inspection Report By Mile - Spring 2015**

**Levee District No. 0001 (Sutter County)**

Waterway	Bank	Unit Miles	Inspection Start/End	Inspector
Unit No. 01 Feather River	Right	16.11	05/20/2015 05/20/2015	Michael Pitta

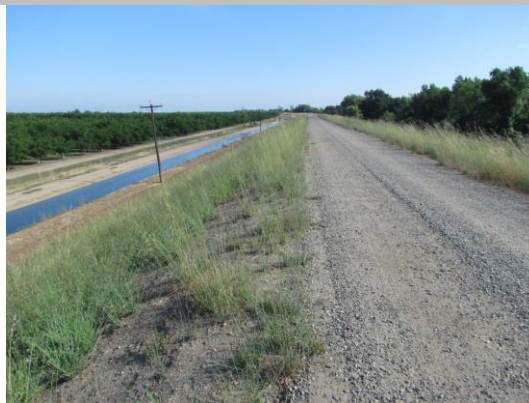
Photo 1 of 1 : SP\_2015\_LD0001S\_433\_13\_20150521\_00009.jpg

LM Start	0.01	Rating **	A/W	Issue No.	13
LM End	4.52	Issue Type +	Ma	Location *	LS
Category	Earthen Levee			GPS Latitude/Longitude	
				Start	End
Item	Vegetation			38.951047 °	39.012715 °
				-121.585744 °	-121.604781 °
DWR ID	DWR_LD0001S_01_s_2015_13				
Action/Comments					
Control annual grass and weeds on the levee slopes and easements.

View of the vegetation on the landside of the levee facing upstream.

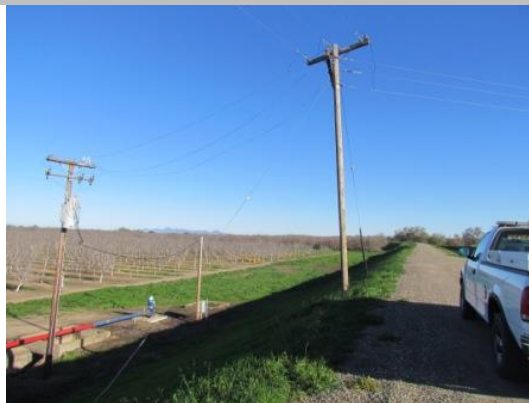
Photo 1 of 1 : SP\_2015\_LD0001S\_433\_8\_20150401\_00001.jpg

LM Start	0.35	Rating **	M	Issue No.	8
LM End	0.35	Issue Type +	En	Location *	LS
Category	Earthen Levee			GPS Latitude/Longitude	
				Start	End
Item	Encroachments			38.955946 °	38.955946 °
				-121.585517 °	-121.585517 °
DWR ID	DWR_LD0001S_01_f_2012_8				
Action/Comments					
Pole					
Inspector Comments: Power pole set on landward levee slope. Spring 2014.

This photo was taken from the crown of the levee facing north looking at a power pole set in the landward levee slope. Spring 2014

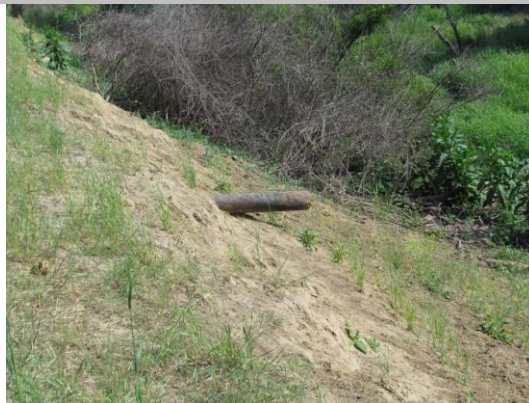
Photo 1 of 2 : SP\_2015\_LD0001S\_433\_487\_20150521\_00010.jpg

LM Start	1.85	Rating **	M	Issue No.	487
LM End	1.85	Issue Type +	Ma	Location *	LS
Category	Interior Drainage & Piping Systems			GPS Latitude/Longitude	
				Start	End
Item	Metal Pipes			38.976927 °	38.976927 °
				-121.591210 °	-121.591210 °
DWR ID	DWR_LD0001S_01_s_2012_487				
Action/Comments					
Inspector Comments: Abandoned pipe. This pipe is listed in our levee log as an abandoned pipe, no date listed. No permit number. Corp pipe.

View of the pipe on the waterside of the levee from the crown facing upstream.

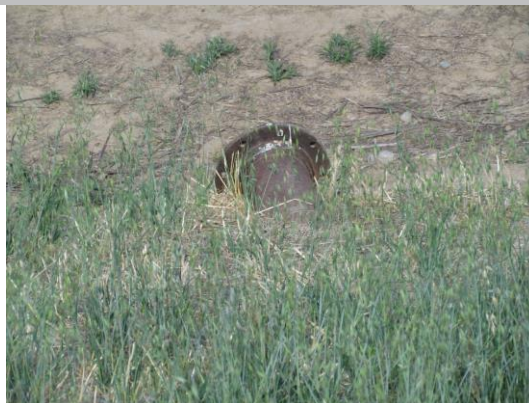
Photo 2 of 2 : SP\_2015\_LD0001S\_433\_487\_20150521\_00011.jpg

LM Start	1.85	Rating **	M	Issue No.	487 (cont)
LM End	1.85	Issue Type +	Ma	Location *	LS
Category	Interior Drainage & Piping Systems			GPS Latitude/Longitude	
				Start	End
Item	Metal Pipes			38.976927 °	38.976927 °
				-121.591210 °	-121.591210 °
DWR ID	DWR_LD0001S_01_s_2012_487				
Action/Comments					
Inspector Comments: Abandoned pipe. This pipe is listed in our levee log as an abandoned pipe, no date listed. No permit number. Corp pipe.

View of the pipe on the landside of the levee from the crown.

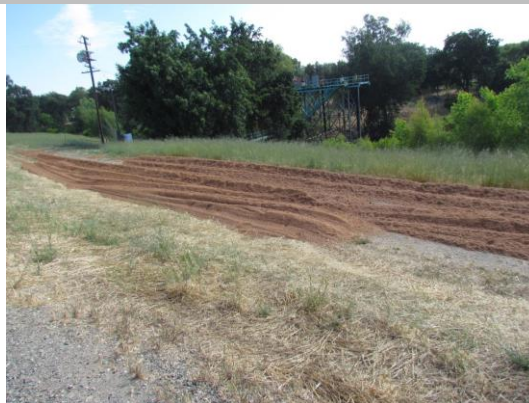
Photo 1 of 1 : SP\_2015\_LD0001S\_433\_16\_20150521\_00012.jpg

LM Start	2.44	Rating **	M	Issue No.	16
LM End	2.44	Issue Type +	Ma	Location *	WS
Category	Earthen Levee			GPS Latitude/Longitude	
				Start	End
Item	Encroachments			38.985446 °	38.985446 °
				-121.591930 °	-121.591930 °

Action/Comments					
Material Inspector Comments: Walnut holes left on waterside of the levee.

View of the material on the waterside of the levee facing upstream.

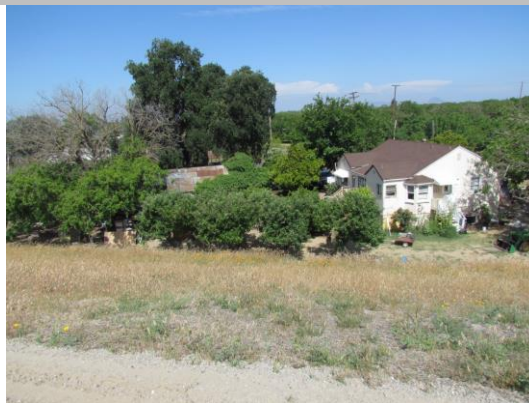
Photo 1 of 1 : SP\_2015\_LD0001S\_433\_489\_20150521\_00013.jpg

LM Start	9.16	Rating **	M	Issue No.	489
LM End	9.16	Issue Type +	En	Location *	LS
Category	Earthen Levee			GPS Latitude/Longitude	
				Start	End
Item	Vegetation			39.076558 °	39.076558 °
				-121.605837 °	-121.605837 °
DWR ID	DWR_LD0001S_01_s _ 2012_489				
Action/Comments					
Landscaping Inspector Comments: Landscaping on landward levee toe.

View of the vegetation on the landside of the levee from the crown.
